CASE STUDY

Outfall Pipeline - Isle of Lewis, UK

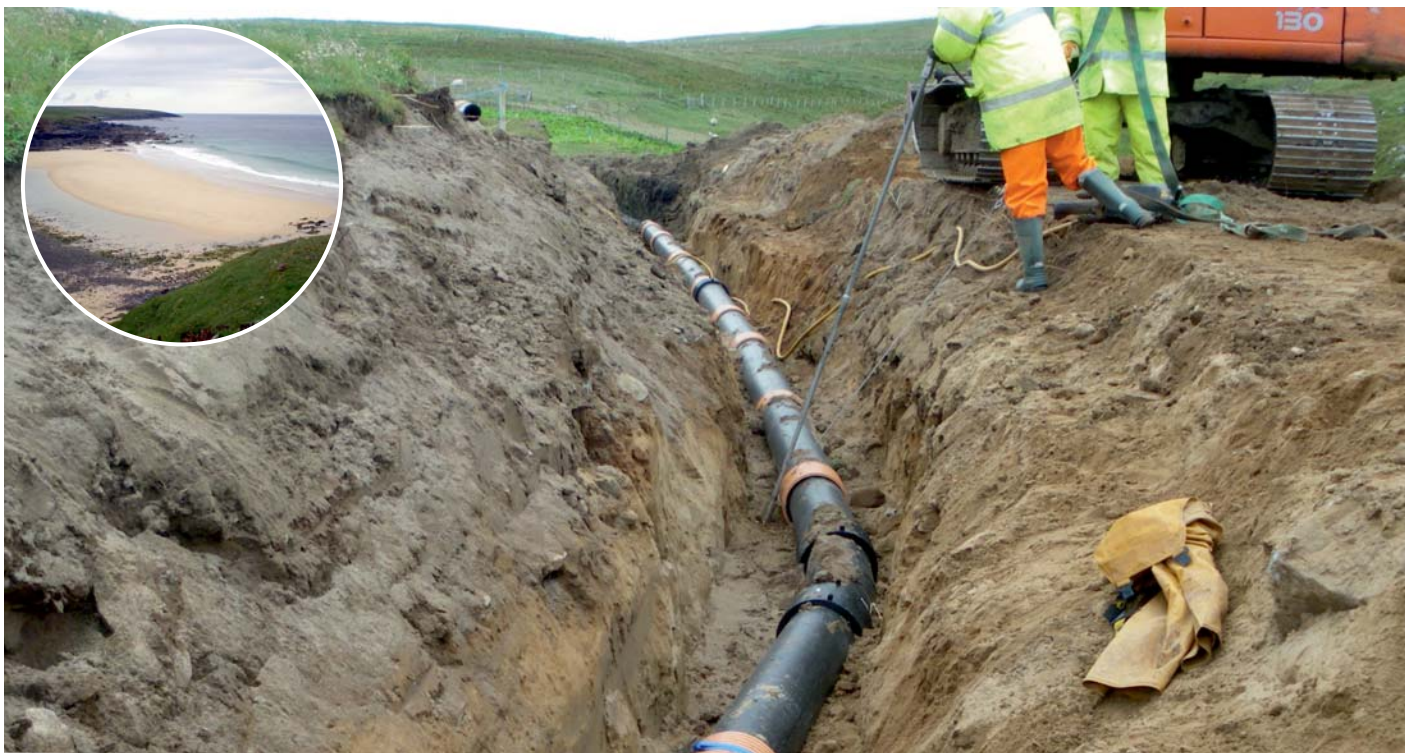
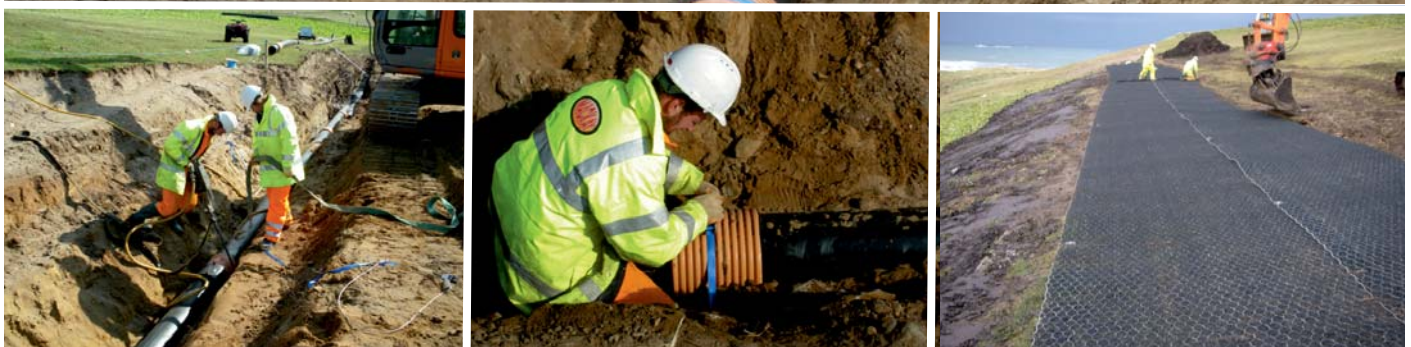
Due to localised shallow slip failures and ground movement along this stretch of the coastline the existing outfall pipeline has in places fractured and broken causing leakage of the pipe contents. This leakage into the surrounding ground has promoted further erosion and movement and increased the damage to the pipe and the surrounding area.

Complete replacement of this 700m long section of pipeline using a 280mm diameter HPPE product was deemed the most cost effective long term solution. To prevent the same fate affecting this new pipeline it was securely anchored into the bottom of a new trench at a depth below any future expected slope failure. Working with limited access the anchors provided a quick and easy way of securing the pipeline. The solution removed the requirement for concrete anchor blocks and minimised the need for machine traffic on site, reducing the damage to the surrounding machair grassland. Once the trench was backfilled S2Geo System anchors were used to secure a MacMatR geosynthetic to minimise any surface erosion and also help quickly regenerate the vegetation growth.

Anchor System: Pipeline - S06EB aluminium bronze anchor c/w 2m of 6mm Ø stainless steel wire tendon, 25mm wide polypropylene webbing strap and stainless steel ratchet fixing. Erosion Control - S2 Geo System c/w 0.6m of 3mm Ø stainless steel wire tendon, 90mm Ø polyethylene plate & aluminium swage.
